This research was motivated for the need of understand the hydrological processes of an Andean watershed.

Diguillin watershed

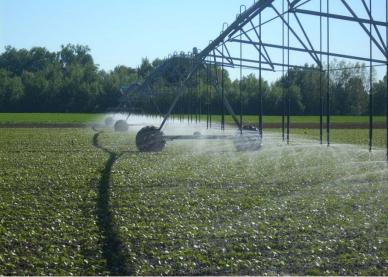
- High inversion on agriculture and irrigation
 - World's highest yield on Sugar Beat
 - Blueberry, wheat, corn and horticultural products

High dependency on water availability and

quality.

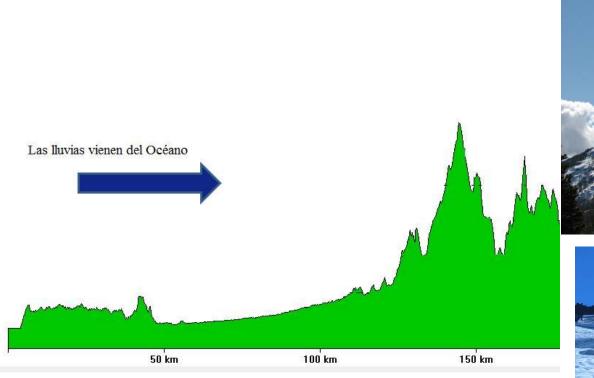
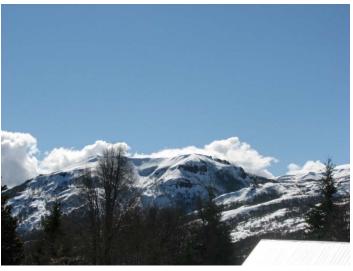
The classical Chilean hydrology focus on snow accumulation and melting process

Which is ok, but does not explain low flow conditions at the Diguillin river

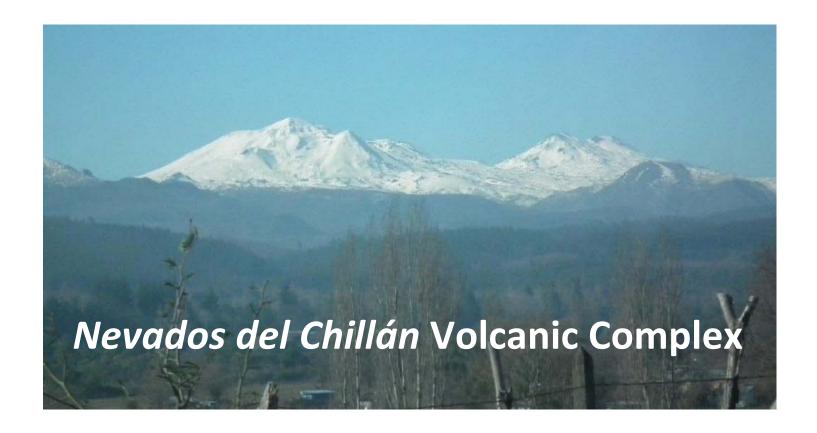
Volcanism controls the hydrology

The upper Diguillin river drains the aquifer located inside the volcanic complex
